## Lidar Characterization of Rainsford Island Bluff, pre- and post-Hurricanes Henri and Ida

Francesco Peri<sup>1</sup>, Alan Bartels<sup>1</sup>, Ian Paynter<sup>2</sup>, Nyla Husain<sup>1</sup>, and Crystal Schaaf<sup>1</sup> 1) School for the Environment (SFE), University of Massachusetts Boston, MA USA 2) Earth from Space Institute (EfSI), Universities Space Research Association (USRA), Columbia, MD, USA

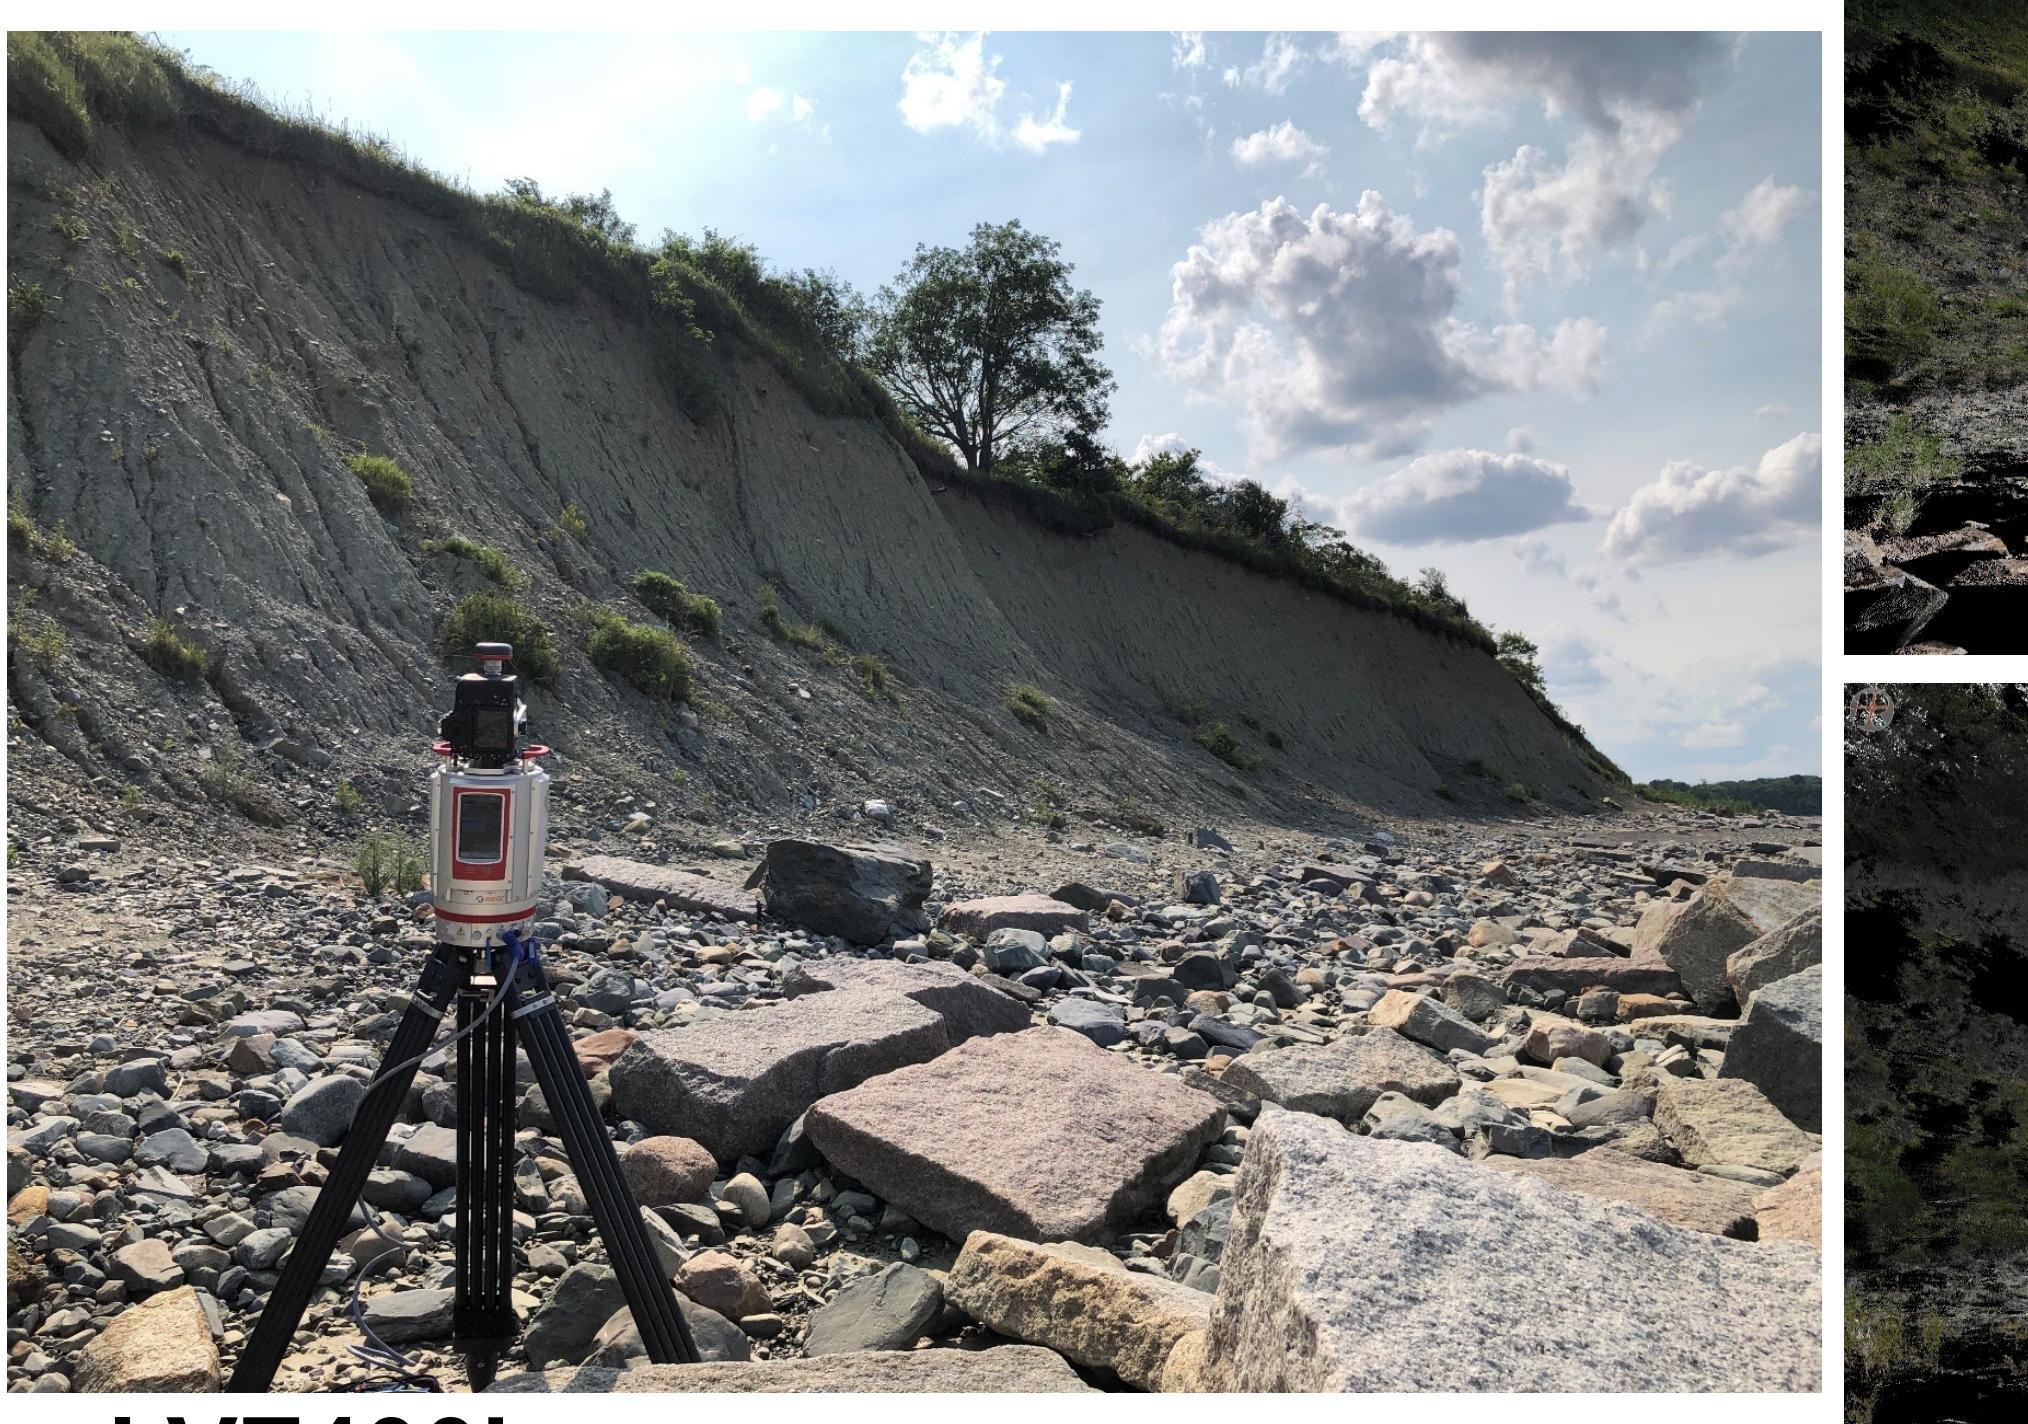
## Riegl VZ400i

**Commercial Terrestrial Lidar** Integrated Nikon SLR camera 1550nm laser (eye-safe) Portable, heavier (9.7kg) Horizontal Scan (2 min) 0.35mrad resolution Range 800m Accuracy 5mm

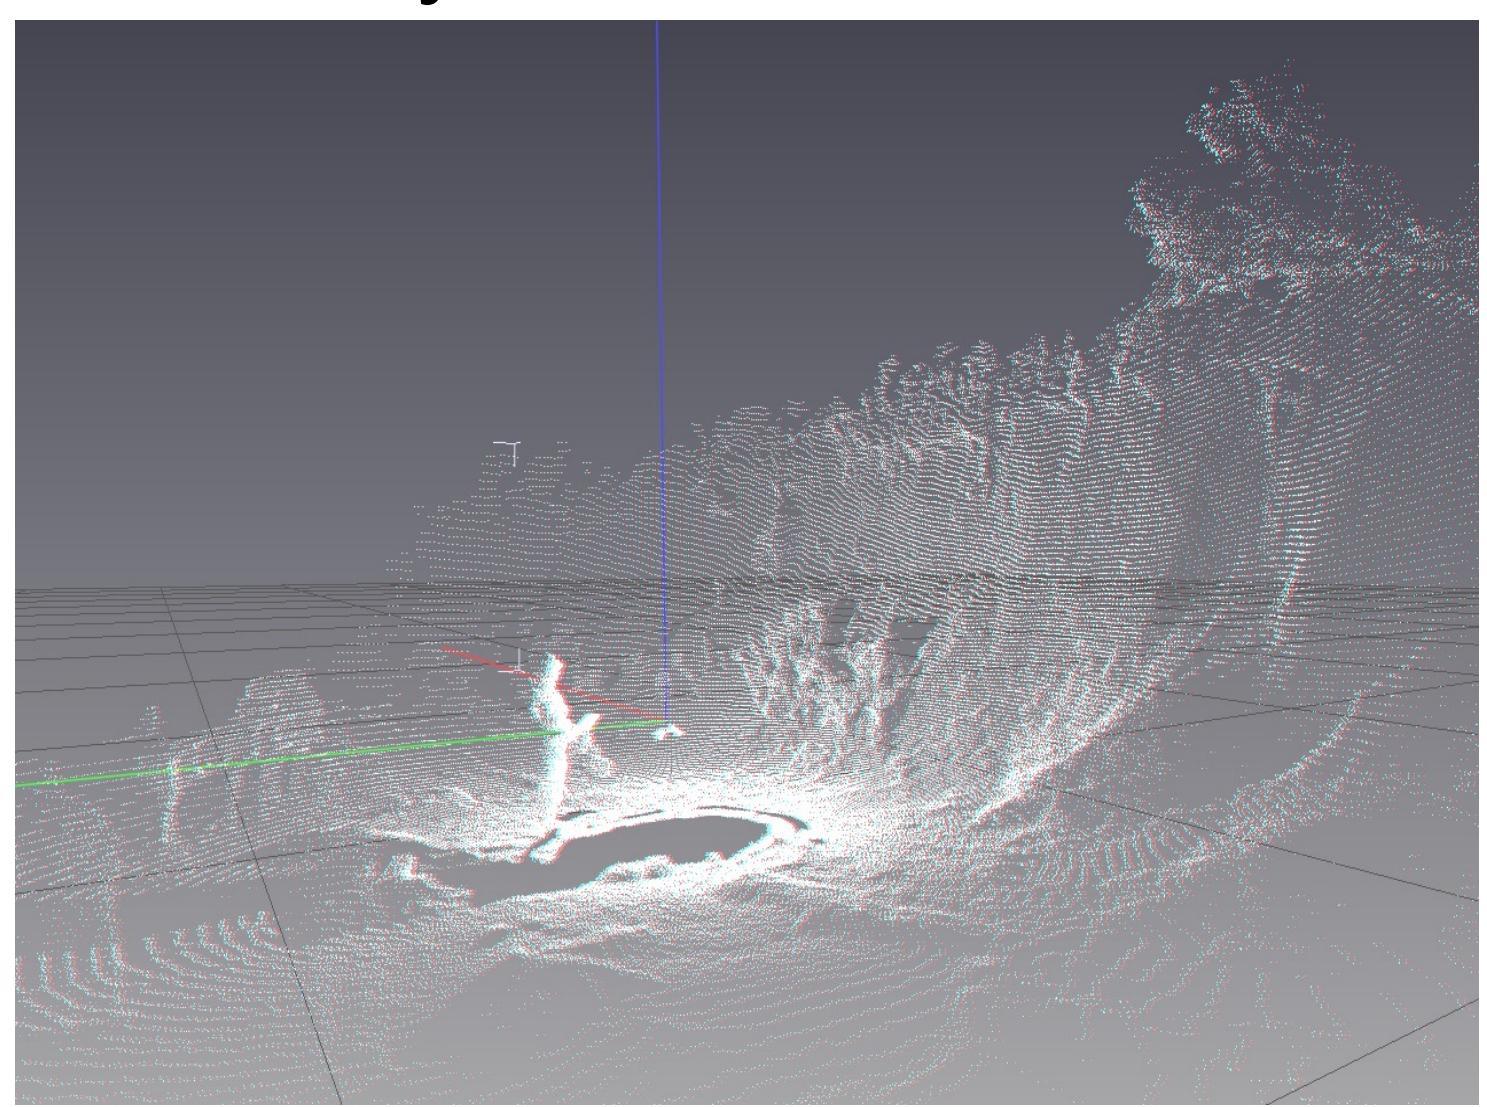
CBL point cloud (with operator)

**Compact Biomass Lidar (CBL) Robust Terrestrial Lidar** Designed by F. Peri, at SFE, UMB 905nm laser (eye-safe) Light, portable (3.9 kg) Fast-scanning Full hemisphere (33s) 0.25° resolution Range 45-60m Although hurricanes Henri and Ida did not inflict significant damage on Rainsford Island, these storms were Accuracy 2-3cm First & 2<sup>nd</sup> returns accompanied with torrential rain that did affect the overhanging vegetation and the bluff face. Deployment of a 2 Million points stationary CBL on the cliff top, will allow assessment of post storm effects, and a decision on whether to deploy Time-of-flight, intensity a team to obtain more rigorous, finer resolution, Riegl VZ400i lidar data for detailed measurement of damage and a better understanding of the geological processes that contribute to erosion on Boston Harbor Islands. Onboard Linux computer (Beaglebone blk) iPhone/iPod remote • Maio, C.V, Gontz, A.M, Tennenbaum, D.E, and Berland, E.P, 2012, Coastal Hazard Vulnerability Assessment of Sensitive Historical Sites on Rainsford Island, Boston Harbor, Massachusetts. Journal of Coastal Research, 28(1A), 20–33. West Palm Beach (Florida), ISSN 0749-0208. WiFi data download • Paynter, I., Saenz, E., Genest, D., Peri, F., Erb, A., Li, Z., Wiggin, K., Muir, J., Raumonen, P., Schaaf, C. 2016. Observing Ecosystems with Lightweight, Rapid-Scanning Terrestrial Lidar Scanners. Remote Sensing in Ecology and <u>Conservation</u>, 1–16. <u>doi: 10.1002/rse2.26</u>
